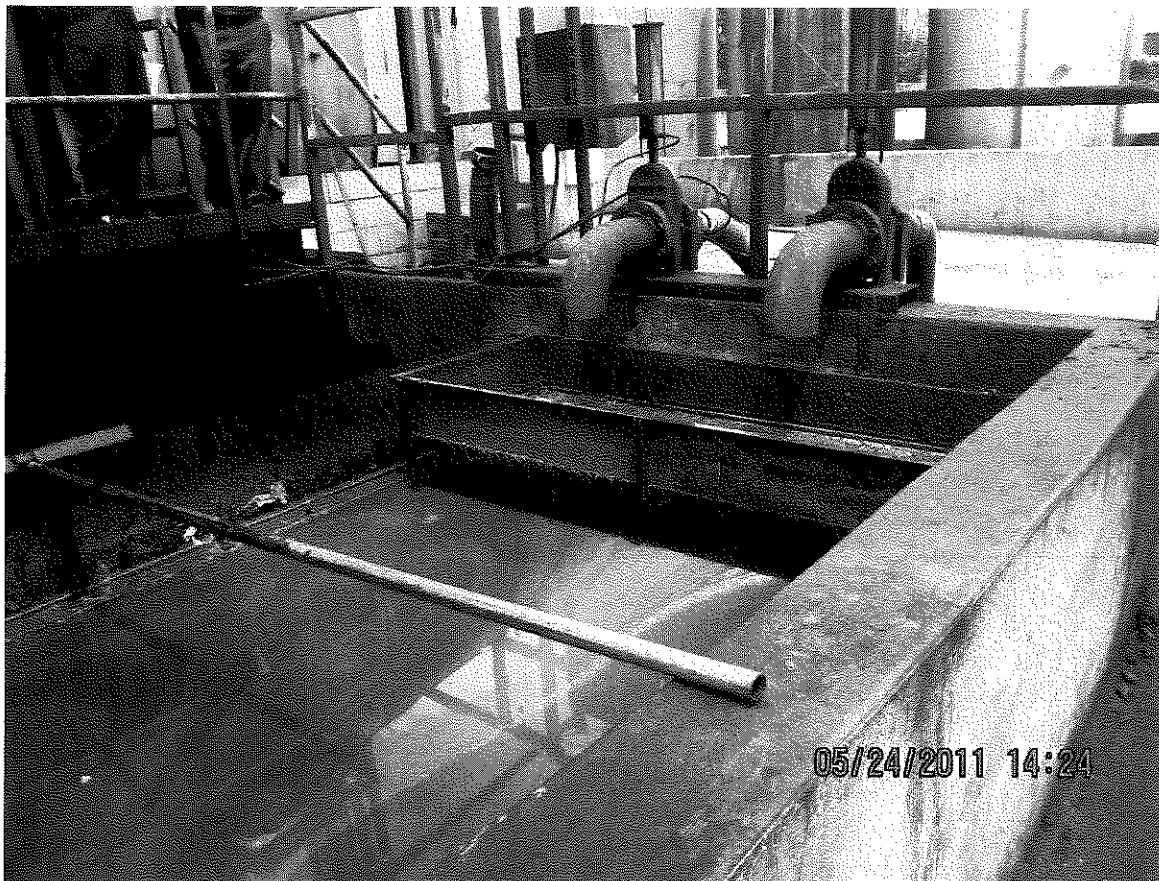
Photograph 1 of 14. Receiving pit with screen. M. Mikulka, U. S. EPA, LCD, 05/24/11, 1424 hrs, Cannon SD1400IS, Ser. No., 212065043412, digital media.

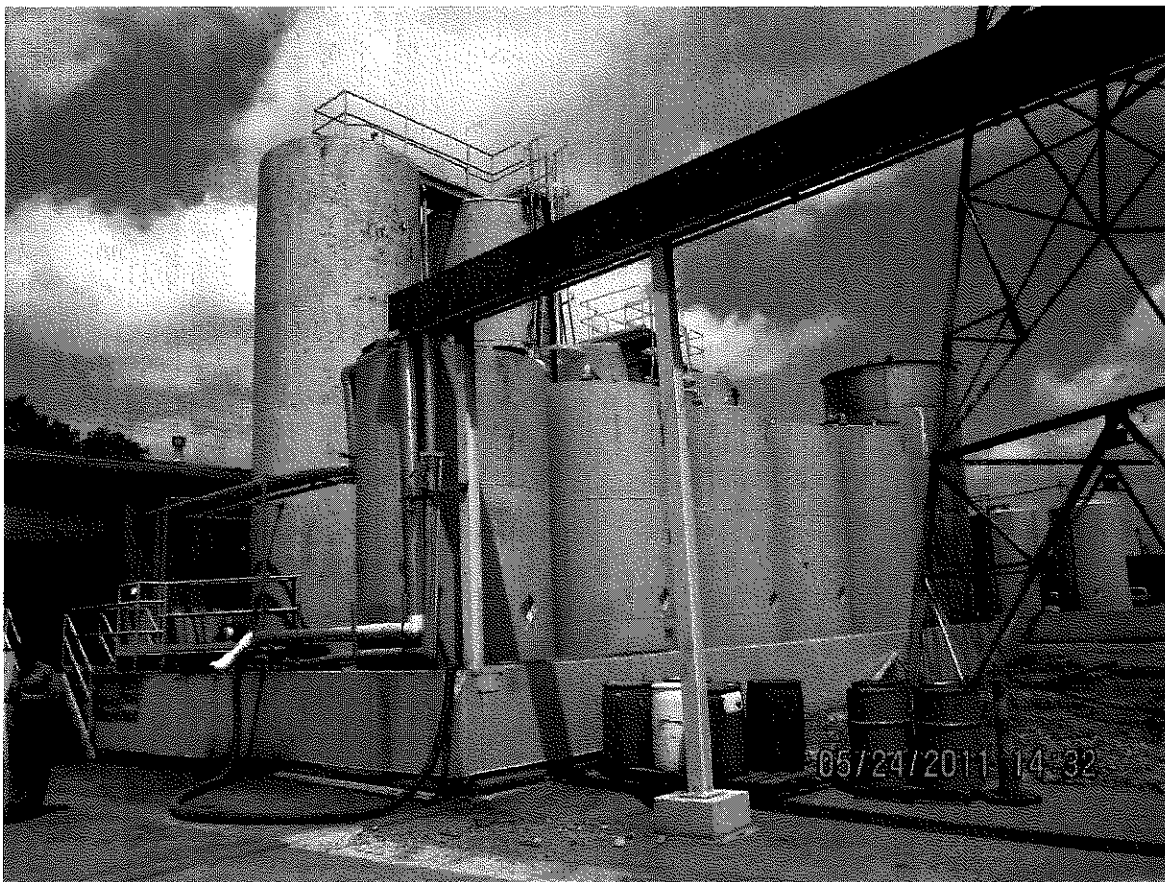
Photograph 3 of 14. Holding tanks for oil to be processed. M. Mikulka, U. S. EPA, LCD, 05/24/11, 1432 hrs, Cannon SD1400IS, Ser. No., 212065043412, digital media.

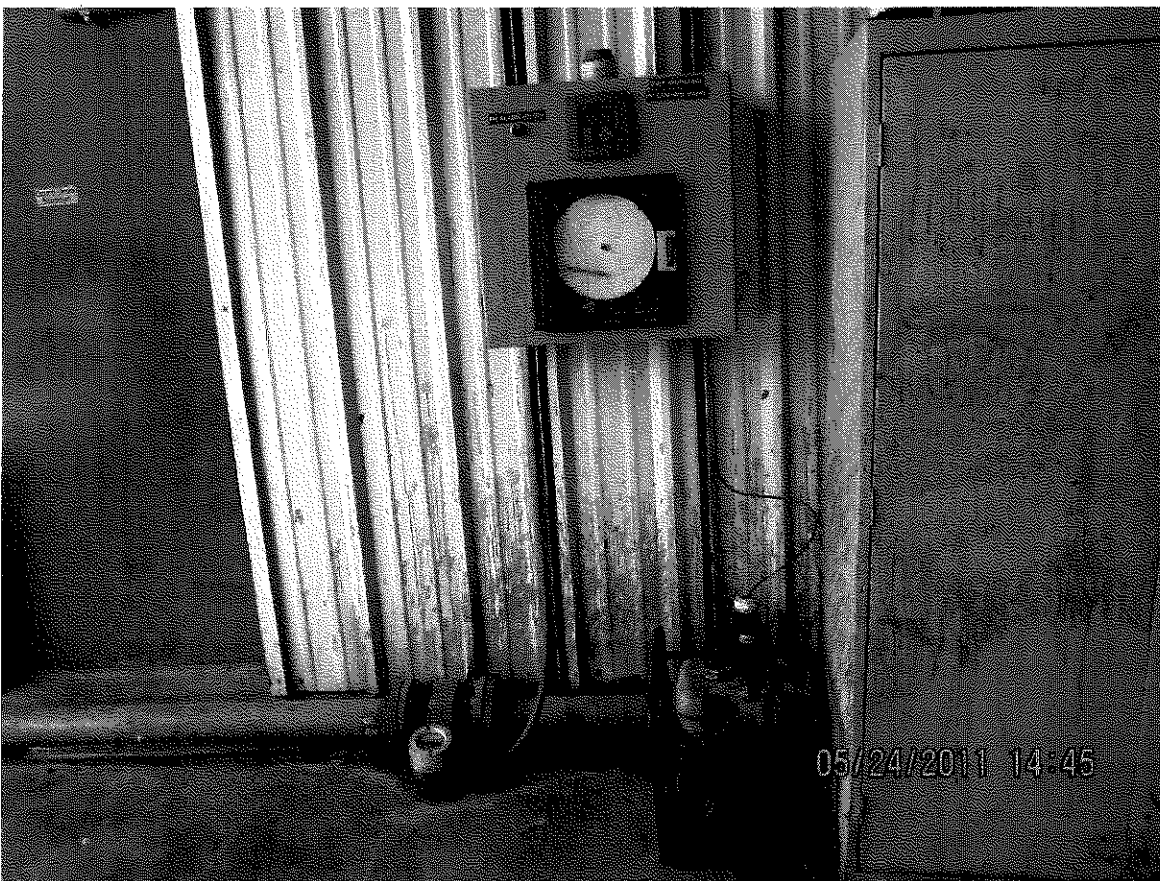
Photograph 4 of 14. Flow meter (on floor by pipe) for discharge to city sewer. pH meter recorder on wall. M. Mikulka, U. S. EPA, LCD, 05/24/11, 1445 hrs, Cannon SD1400IS, Ser. No., 212065043412, digital media.

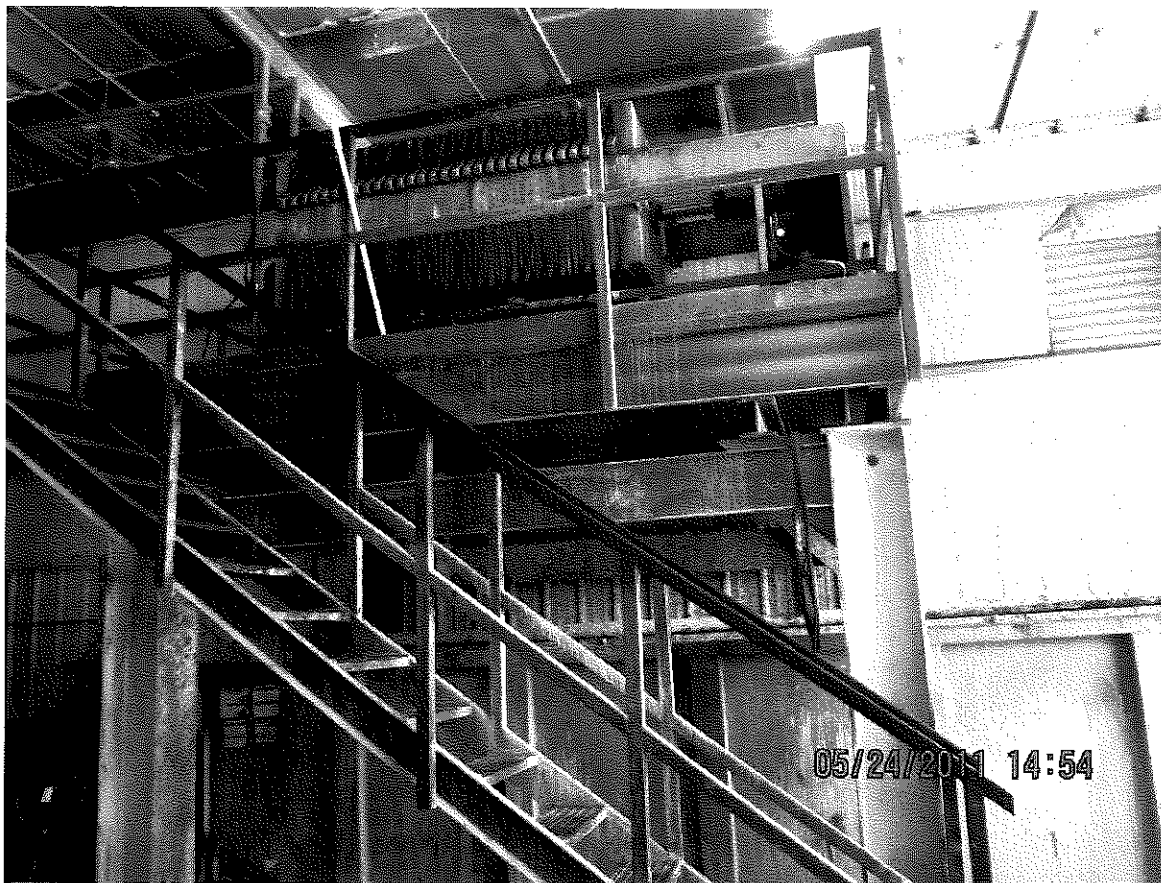
Photograph 5 of 14. Filter press (on top) and dumpster for filter cake. M. Mikulka, U. S. EPA, LCD, 05/24/11, 1454 hrs, Cannon SD1400IS, Ser. No., 212065043412, digital media.

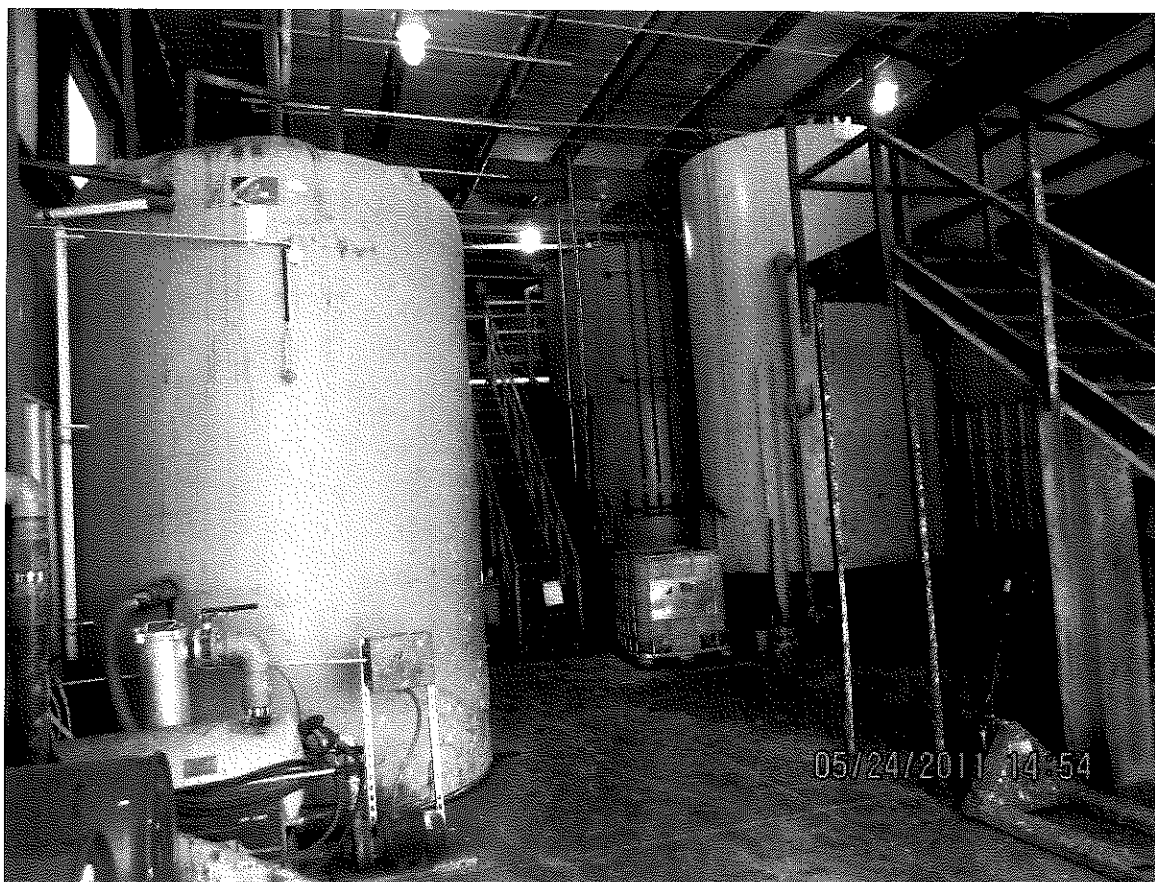
Photograph 6 of 14. Discharge tank to city sewer at left, water treatment tank in back right. M. Mikulka, U. S. EPA, LCD, 05/24/11, 1454 hrs, Cannon SD1400IS, Ser. No., 212065043412, digital media.

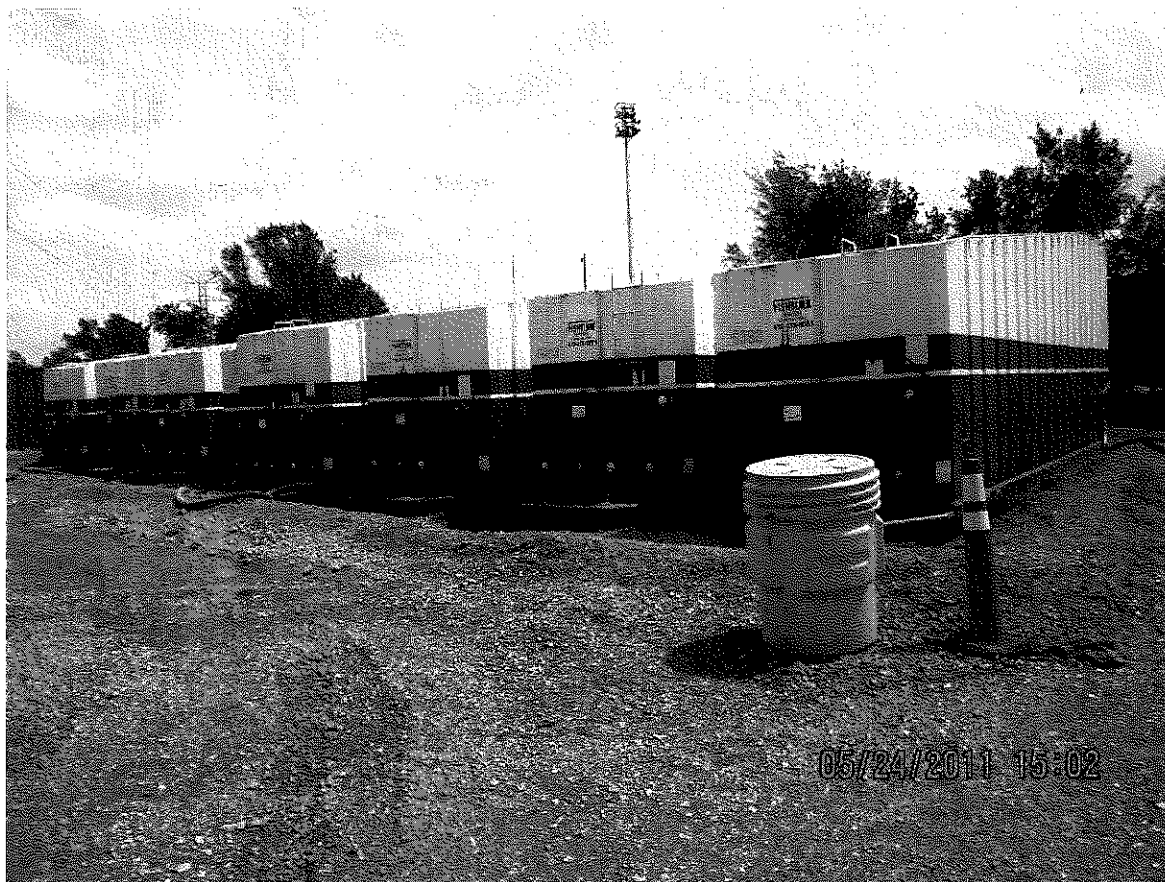
Photograph 7 of 14. Frac tanks that receive subcontractor oils. Tank at far right has 33 ppm PCBs and was locked out. M. Mikulka, U. S. EPA, LCD, 05/24/11, 1502 hrs, Cannon SD1400IS, Ser. No., 212065043412, digital media.

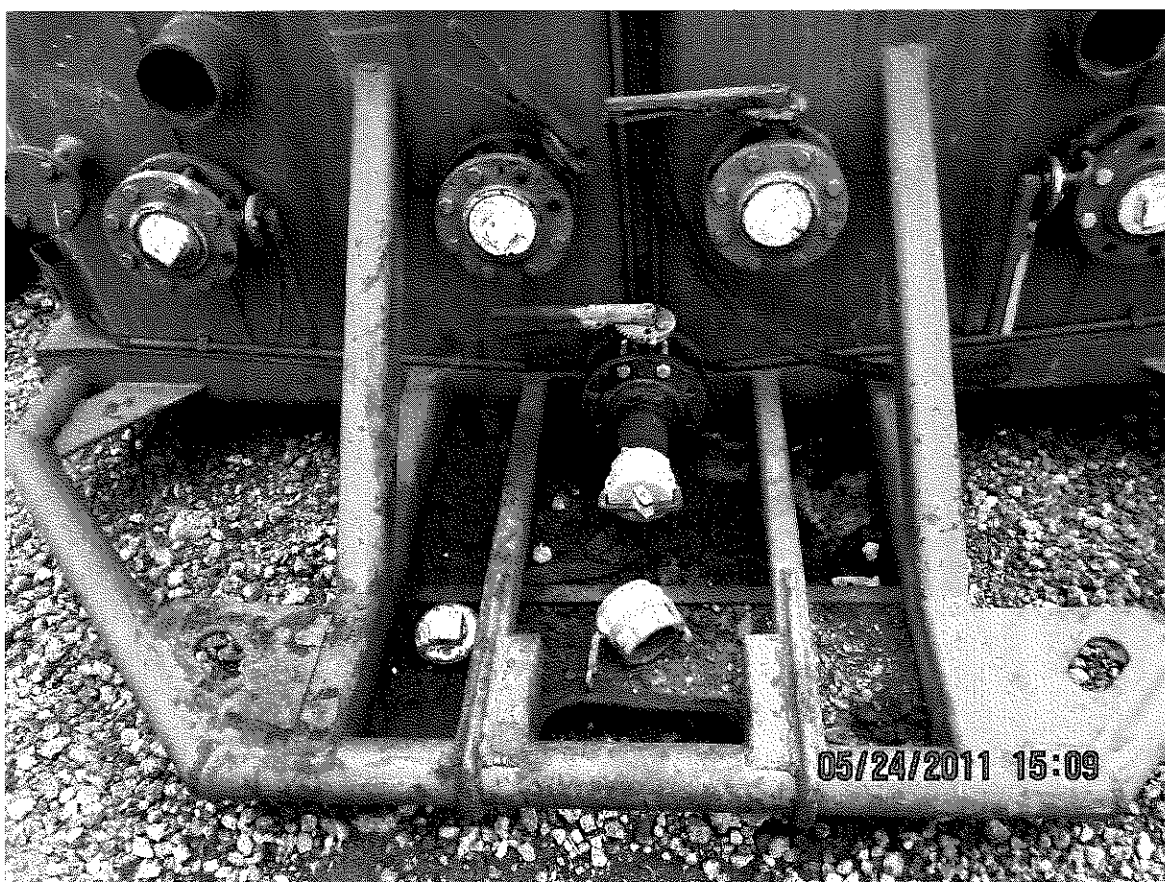
Photograph 8 of 14. Valve of frac tank #6383 (which has 33 ppm PCBs) with lock. M. Mikulka, U. S. EPA, LCD, 05/24/11, 1509 hrs, Cannon SD1400IS, Ser. No., 212065043412, digital media.

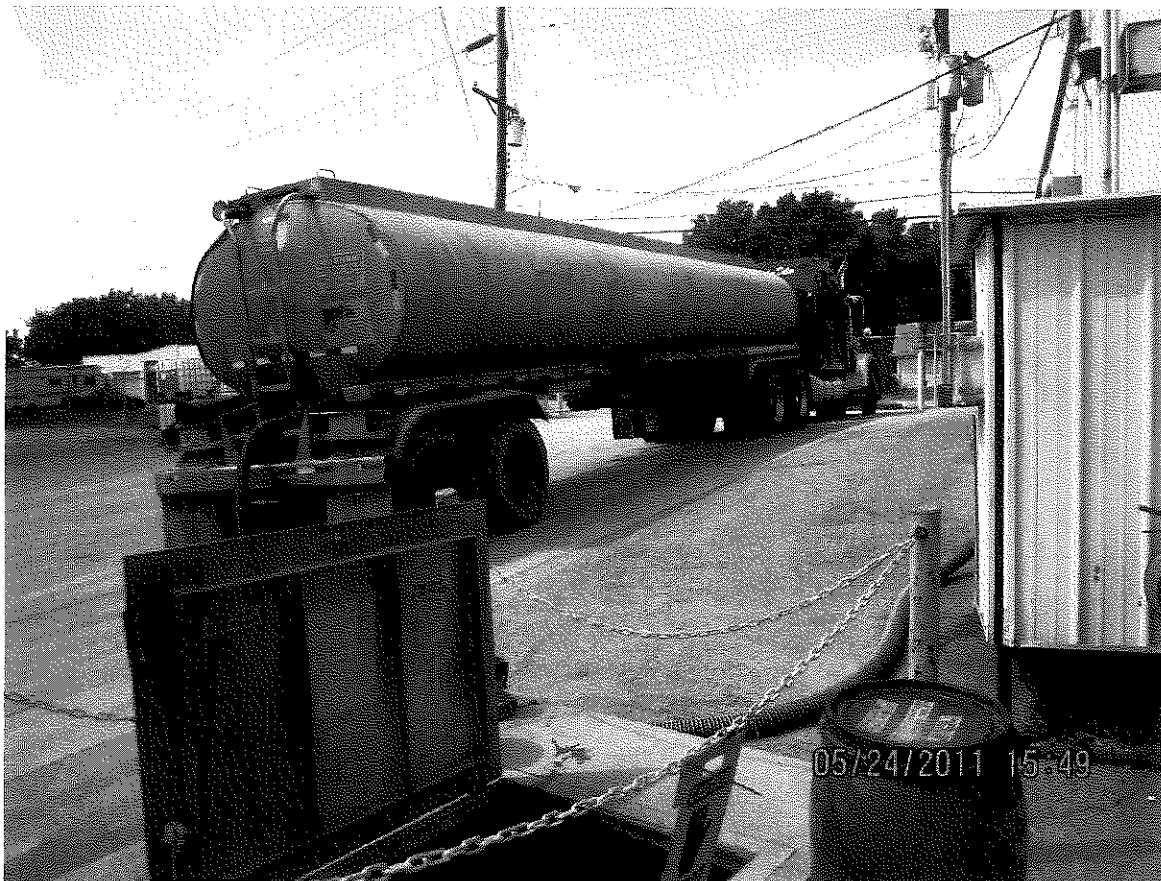
Photograph 13 of 15. Truck from landfill discharging landfill leachate to filter which discharges to city sewer. M. Mikulka, U. S. EPA, LCD, 05/24/11, 1549 hrs, Cannon SD1400IS, Ser. No., 212065043412, digital media.

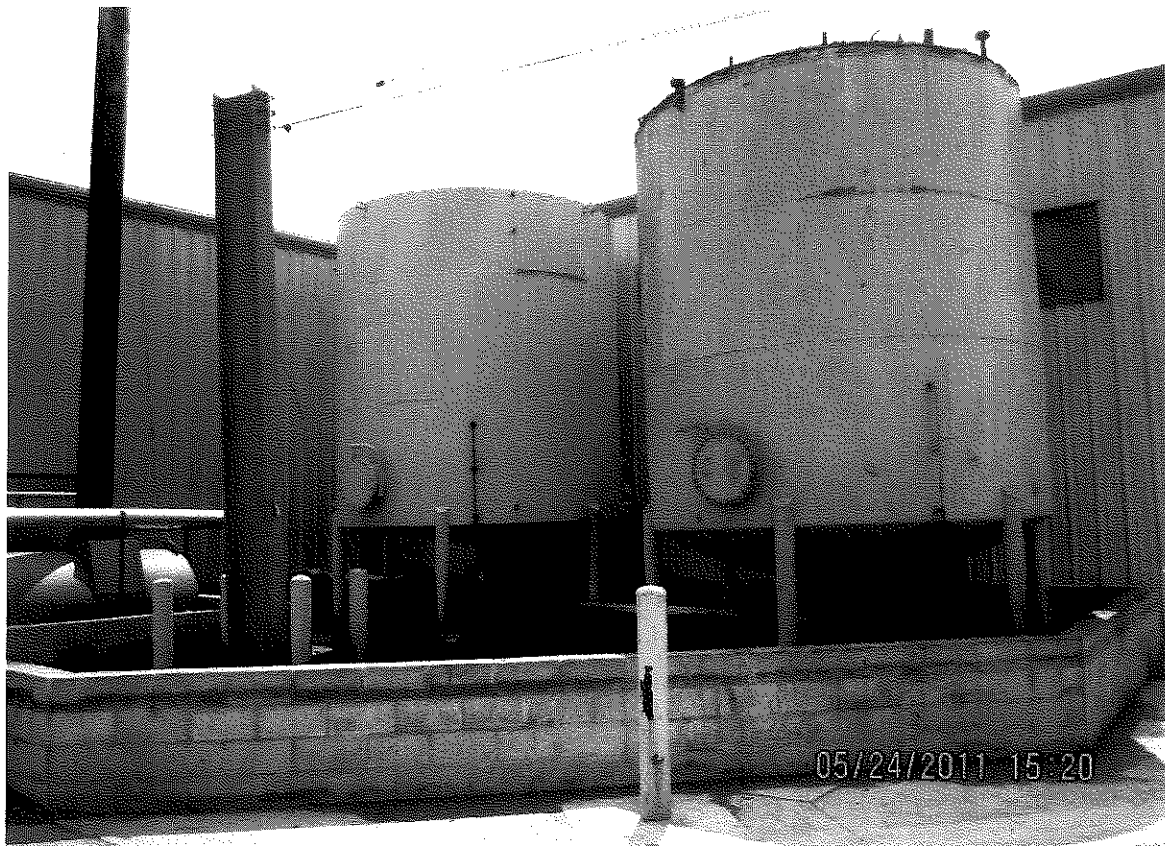
Photograph 9 of 14. Processed (outbound) oil tanks. M. Mikulka, U. S. EPA, LCD, 05/24/11, 1520 hrs, Cannon SD1400IS, Ser. No., 212065043412, digital media.
